1948-49 "60"
1948-50 "75"
1948-50 Land-Rover

ENGINE

1. ENGINE MISFIRING
2. SPARKING PLUGS FAULTY

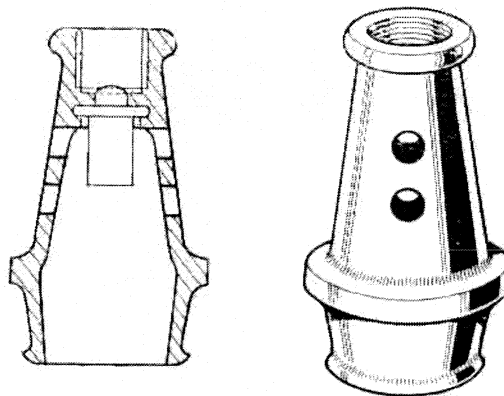
CAUSE Condensation inside sparking plug cover.

Examination of alleged faulty sparking plugs returned to us, and investigation of complaints of misfiring and kindred troubles, have shown that only in rare instances are the sparking plugs actually defective. In almost all such cases, the fault lies in condensation inside the plastic plug cover; it should be remedied as described below. It must be emphasised that Lodge H.L.N.R. plugs are fitted as standard on these models and must be used for all subsequent replacements.

Fig. 1 Modification to sparking plug cover.

- REMEDY.
1. Remove the sparking plug covers and dry thoroughly.
 2. Drill four $\frac{3}{16}$ in. (4,8 mm.) holes in the cover as shown at Fig. 1. The lower holes

are drilled on the same centre line as the existing $\frac{1}{8}$ in. (1,6 mm.) ventilation hole; the upper holes should be positioned at $\frac{3}{8}$ in. (9,5 mm.) centres above the first holes.

3. Remove, clean and dry the sparking plugs; re-set the gaps as necessary and replace.
4. Replace the covers with the holes lying to front and rear, *i.e.*, with the holes parallel to the engine centre-line. In this way the air flow assists in evaporation of any condensation.
